INSTALLATION RESTORATION PROGRAM PHASE II - CONFIRMATION/QUANTIFICATION STAGE 1

VOLUME I

CHANUTE AIR FORCE BASE RANTOUL, ILLINOIS

FINAL REPORT FOR PERIOD OCTOBER 1984 TO OCTOBER 1986

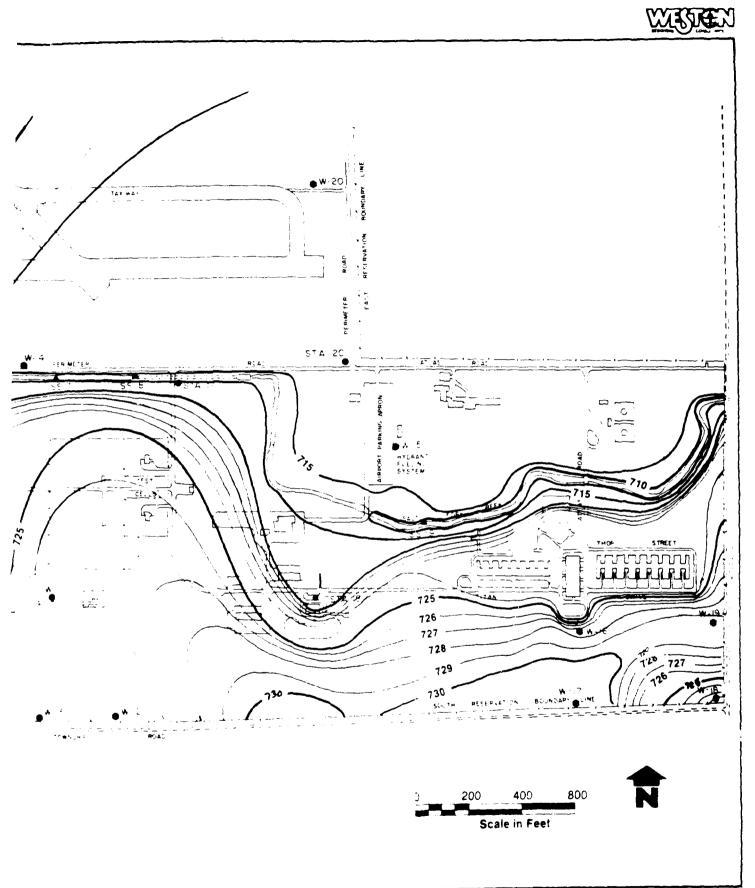
FIGURE 4-3 CONFIGURATION OF POTENTIOMETRIC SURFACE OF THE SHALLOW (UPPER) AQUIFER: 13-20 FEBRUARY 1985

Groundwater beneath the Fire Protection Training Area occurs under water table conditions within outwash sand and gravels. The sand and gravel beds range in thickness from 1 to 5 feet in thickness and provide preferred zones of groundwater flow. A laterally continuous sand and gravel zone was encountered at approximately 20 feet BLS (700.0 feet MSL) in wells W-1, W-6 and W-5 located in the eastern and southern areas of the FPTA-2. The locations of these wells are shown in Figure 3-2. Groundwater occurs from 2 to 7 feet BLS, 720 to 725 feet MSL. Based upon water level elevations recorded in February and March 1985, the potentiometric surface maps shown in Figures 4-3 and 4-4 were developed. From the configuration of the water table in the FPTA-2 area, as shown in these maps, an average hydraulic gradient of 0.0064 was calculated, sloping west-northwest toward Salt Fork Creek. The hydraulic gradient steepens sharply adjacent to the creek suggesting that the conductivity of the glacial till is low (10 to 10 cm/sec). Wells W-1, W-5 and W-6 are upgradient of wells W-4, W-2 and W-3. Distinct groundwater mounding in the FPTA around W-1 in February 1985 is shown in Figure 4-3.

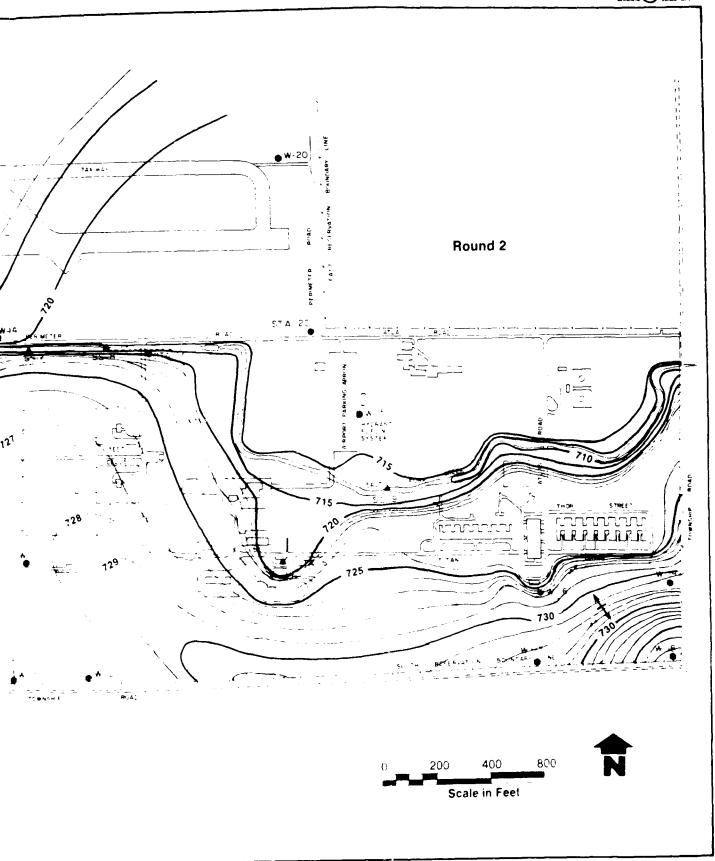
FIGURE 4-4 CONFICURATION OF POTENTIOMETRIC SURFACE OF THE SHALLOW (UPPER) AQUIFER, 19-26 MARCH 1985

However, the March 1985 water table contours (Figure 4-4) show no mounding. Soils were still frezen in February and water table elevations were lower relative to the water table elevations recorded in March. It is possible that the infiltration of water associated with training activities in the vicinity of Buildings 902 and 906 is responsible for the acretion of this mound.
